### 3.3 Baseline surveys and inferences

#### A. Topography and hydrogeology assessment (Refer to folder 1 for detailed reports)

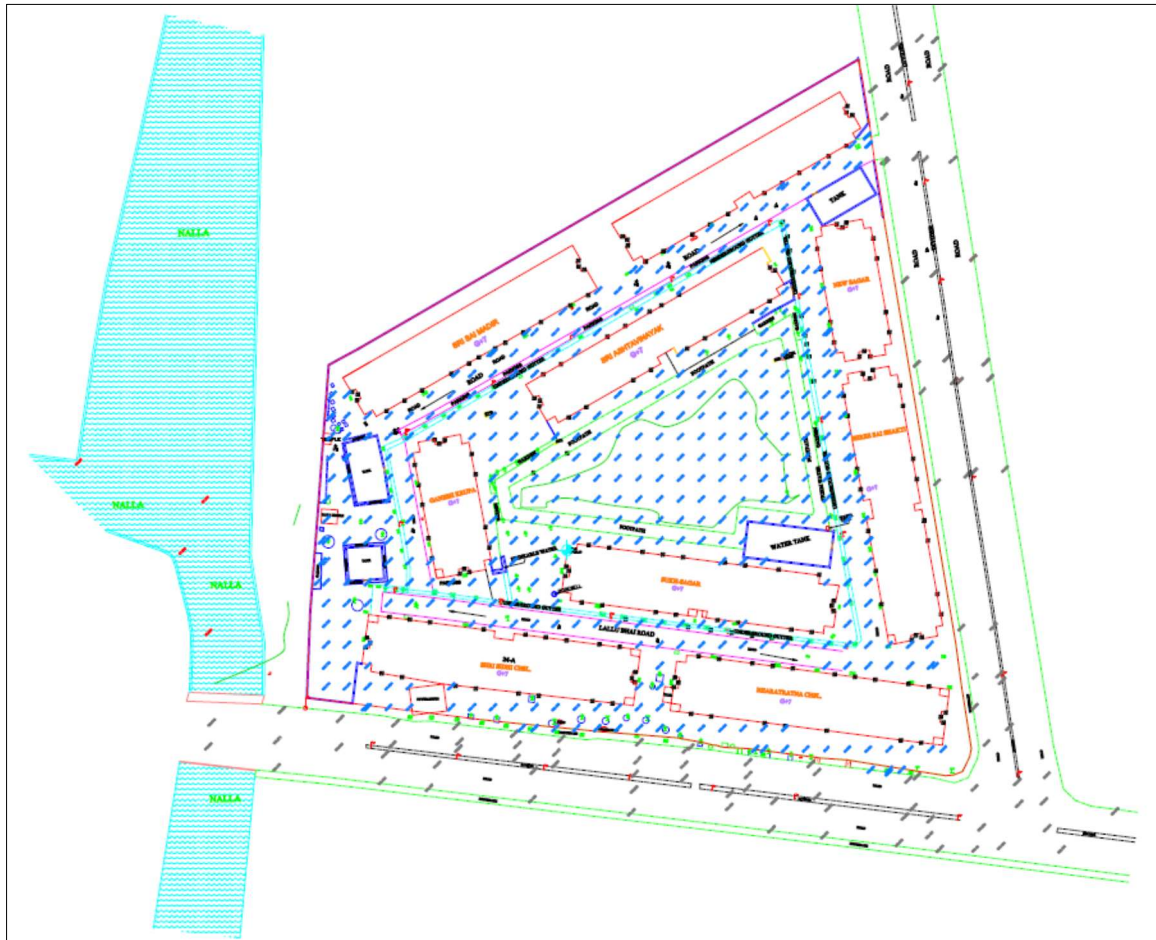
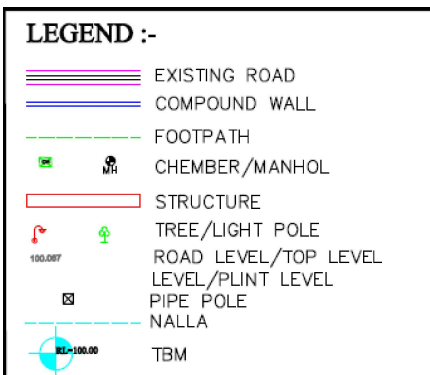
Figure 3.20 Survey produced by Rane Management Consultant Pvt. Ltd. recording levels and as build structures

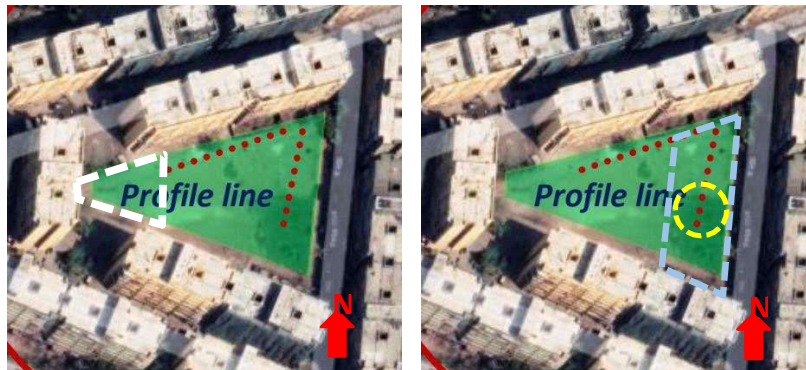
- In Figure 3.21 (Left) below red dotted line represents the profile line of scan done as per this survey. Area shown with white dotted line was not scanned as per the consultants due to challenges in scanning like insufficient area, close proximity of building foundation and water logging in central portion of maidan which were restrictions for electrodes to spread and scan.

- As per the scanning result on north south direction scan which is up to depth of 100 m. there is presence of an underlying aquifer at scan 7 number and Probable groundwater yield for same site is 1100 to 1400 (lph) at scan 7 number. As shown in figure 3.21 (Right) Scan no. 7 will fall under the zone shown with yellow dotted line.

- As mentioned in the report This site is recommended for plantation work as well as groundwater recharge work based on scientific resistivity field investigation survey of soil-rock strata and soil quality testing at laboratory.

Figure 3.21 Hydrogeology survey extent. (Left) Red dotted profile line shows 300 meter depth scan from west to east; 100 meter depth scan from north to south. Zone with white dotted line is not scanned. (Right) Blue dotted line shows the area suitable for recharge system; yellow dotted line zone shows the proximity of underground aquifer.

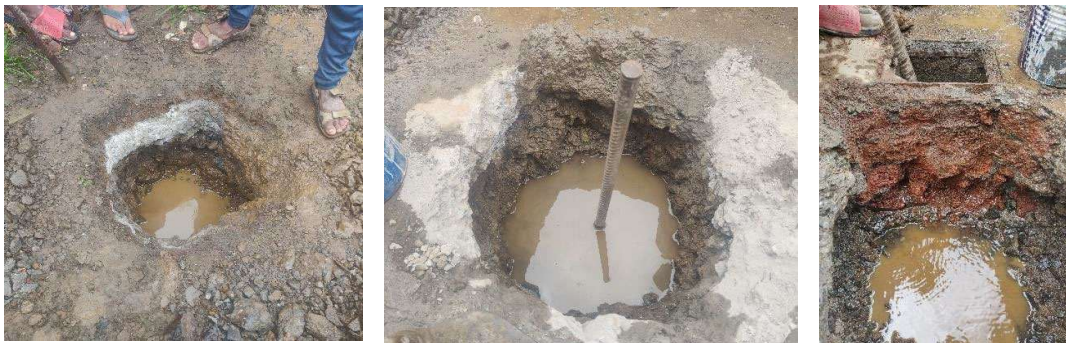
- Test pits to check the strata of maidan during month of august the 150 mm of concrete slab was observed in concretized area and mix of murrum and Malaba below this 150mm slab.

- Water saturation was observed in all the pits after digging up to 0.75 m – 0.9 m.
- Also locals mentioned that there is presence of water at certain depth (up to 1.2m) throughout year as per their observation and previous digging experience in and around maidan.

Figure 3.22 Pits done in 5 places on site during month of August showing layers of strata and water saturation levels.
