# URBAN GREENING INITIATIVE BASELINE SURVEY INCLUDING RAPID BIODIVERSITY SURVEY

## REPORT

**Submitted to: WRI**

**Project Duration:** July 2022 – May 2023

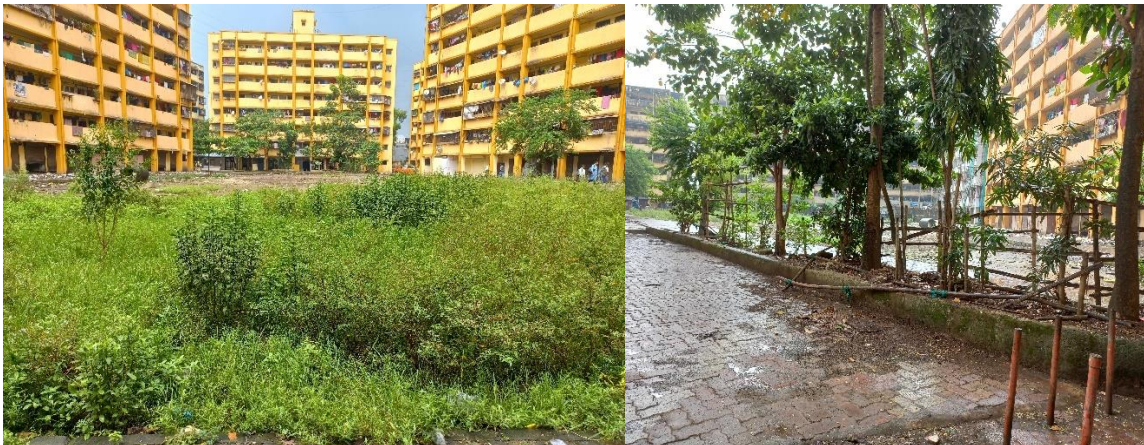
- **Vegetation:** It is an open ground surrounded by buildings on all four sides and there is a road on one side. The vegetation present on the ground is on the three boundaries which are mostly ornamental and fruit plants planted by the residents. A wild patch of herbs can be seen on the broader end of the ground on one side. This patch mostly contains grasses and herbs. And, few species which grow in waterlogged areas.

Wild plant patch

Planted by residents

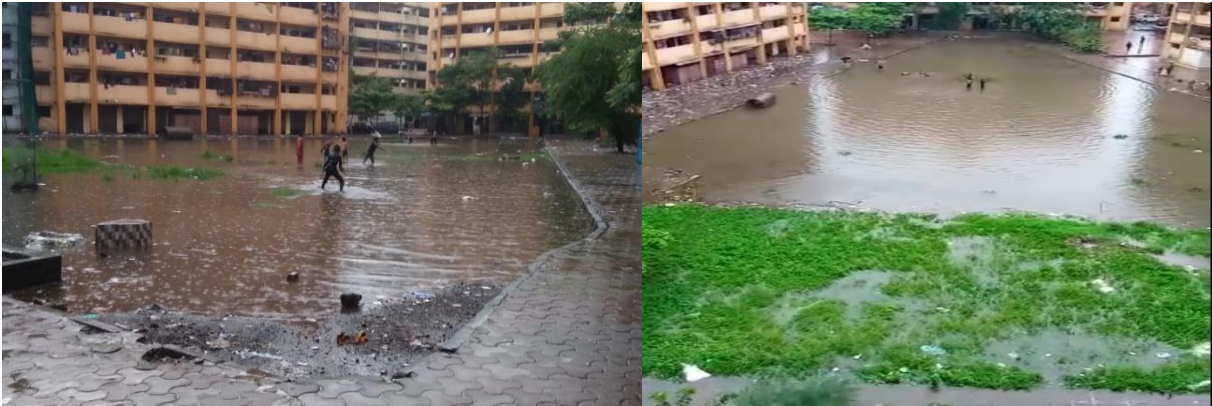
- **Soil:** The ground is covered with a concrete base on which some amount of soil is added on one side of the ground in an attempt to develop a garden. Paver blocks are installed along the edges on all sides. The soil quality is poor and contains concrete.
- **Water logging:** Site faces rain water drainage issues and hence gets water logged during monsoon. Also as there is a concert platform below the ground the water cannot percolate. The water from the terrace is also released in the ground as the pipes from the terrace are just left open at the building base.
- **Garbage:** Garbage is a big issue at the site. Residents throw garbage at the site.
- **Rats:** Rats were seen at the site feeding on the garbage thrown by the residents.
- **Pigeon feeding area:** Residents feed pigeons in the area at one side.

Water Logging during the monsoon

Mankhrud site is good for plantation provided it is developed as an elevated garden and soil and manure are added to the site. Trees, herbs and shrubs can be planted.

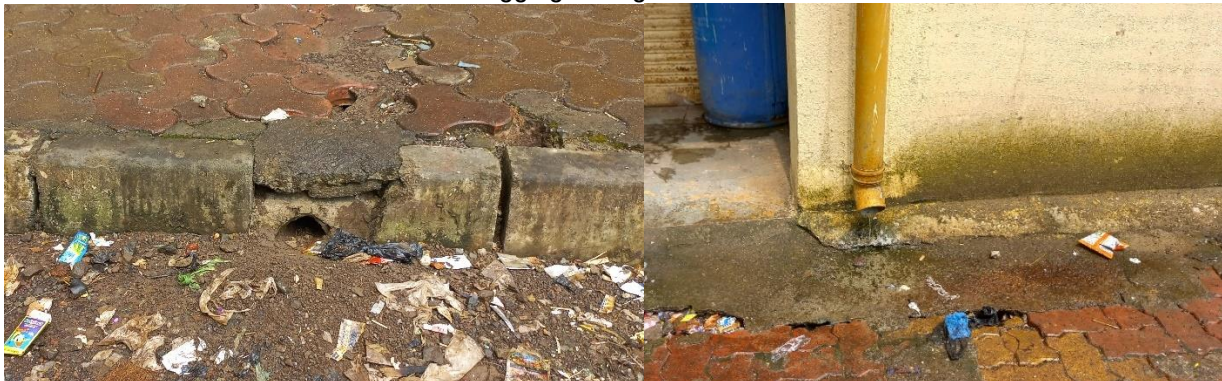
Rain drainage on paved pathway on edges

Rain drainage pipes from terrace

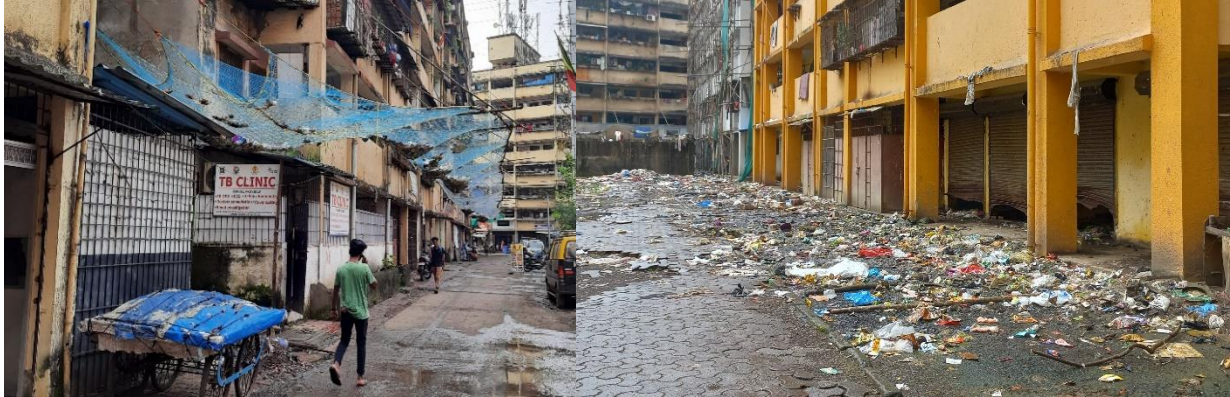
Garbage thrown by local residents on the ground

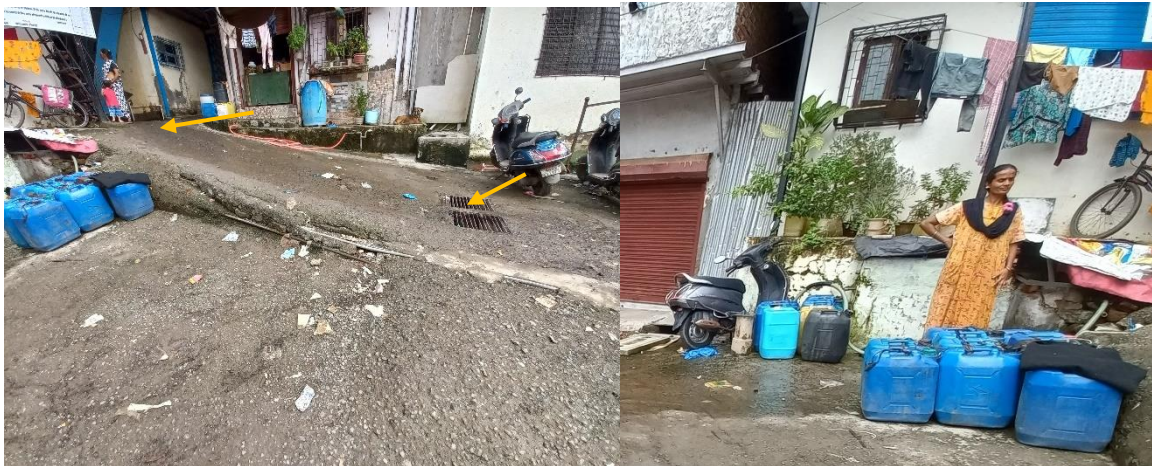
- **Small Area:** It is a very small area for tree plantation.
- **Way for rain water run off:** Rain water flows down from the site and get collected in the parking area which gets water logged during monsoon.

All the water from the huts area flows through the ground

Drinking water tap

Malad site is not suitable for plantation as the area is very small and it is used by residents for parking and children's use it for playing.

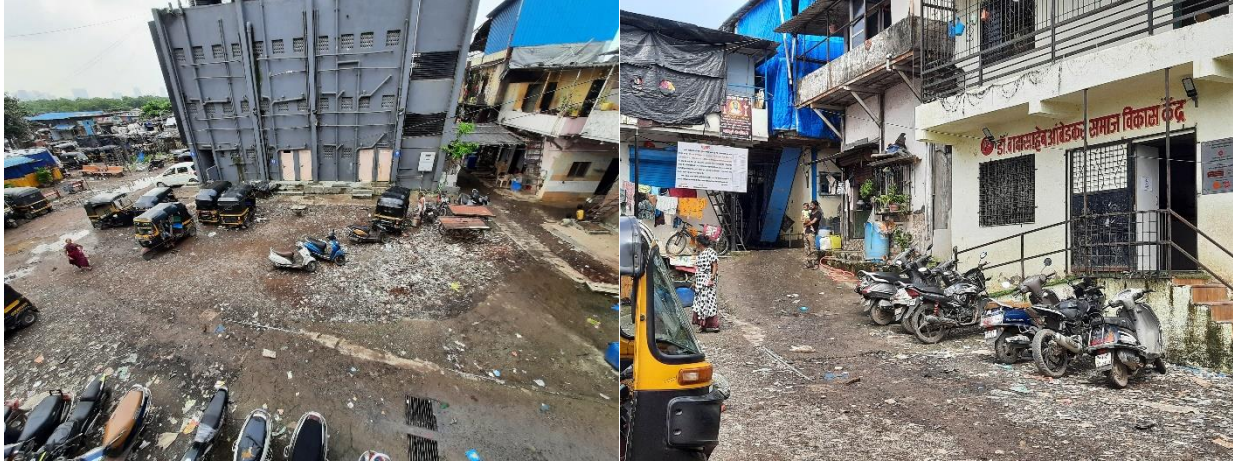
- **Play ground:** The site is used by local children for playing.
- **Parking:** It is used as parking area by locals to park auto-rikshas, bikes and Thela Gadi (push cart).

Auto-rickshas and thela gadi and motor bikes parked at the site
