The current project is located in Lallubhai Compound (Mankhurd, Mumbai) and covers a gross area of about 18700 sq.m., with 9 buildings. However, nature based solutions (NbS) and other interventions are planned for smaller area of 6,656 sqm covering Lal Maidan, three buildings (5 wings), pathways along the perimeter of the maidan and the circulation space shown in purple in Figure 3.3.

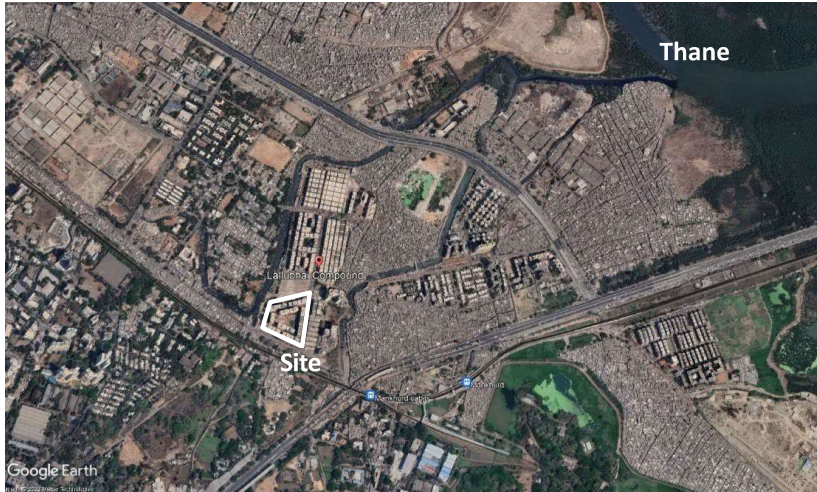
Figure 3.6 Project scope- Area demarcation

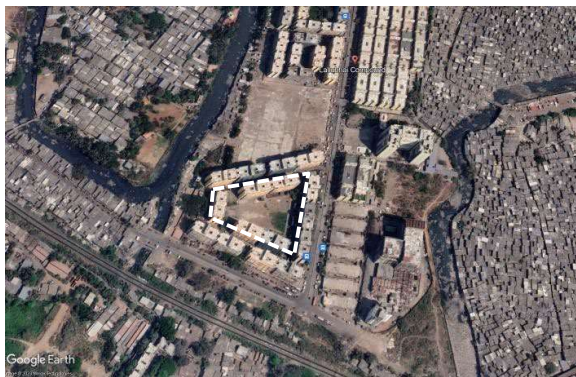
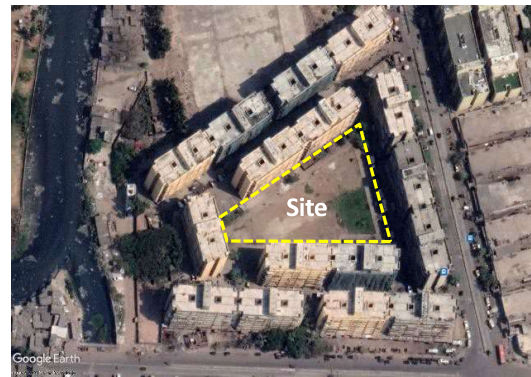
Figure 3.7 Lal maidan context- in between creek tidal channels.

- As seen in figure 3.7 Lallubhai compound and the developed area around it has spread till the edge of Thane creek, which once were drainage areas of Thane creek and were possibly covered with mangroves which used to act as absorptive sponges of rainwater and tidal water.
- Due to current development done by destructing these mangroves and tidal basin has reduced the absorption of water.
- Figure 3.8 showcases concretized edges of tidal channels which results into no absorption or no natural drainage of storm water from surrounding area into these channels.

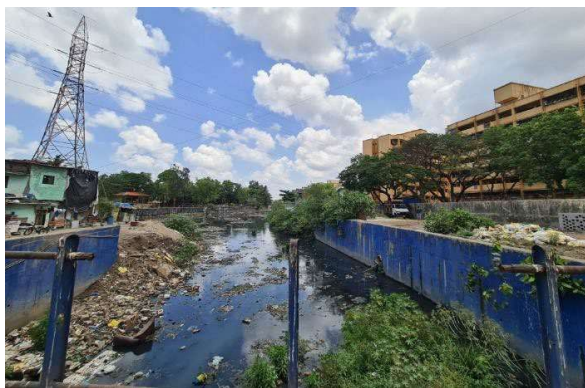
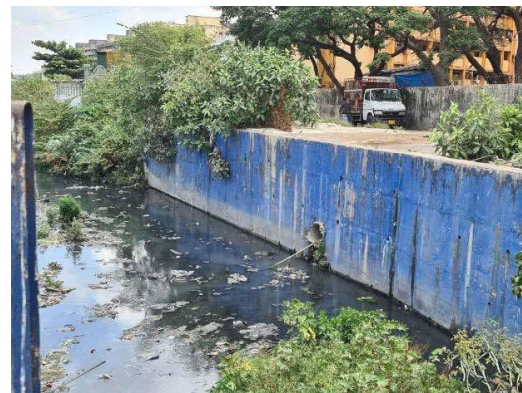
Figure 3.8 Nearest Tidal creek channel (nala) on west side of site.

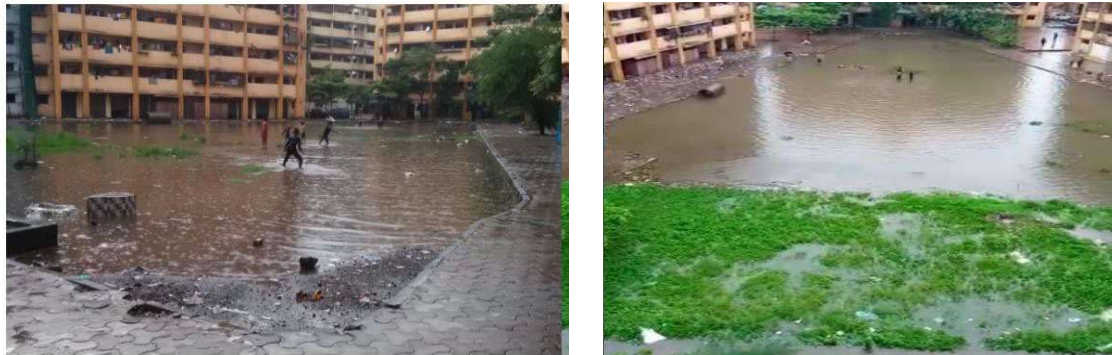
Lal maidan itself, experiences a high amount of waterlogging during monsoon months. This is primarily due to the concretization of the maidan; flow of rooftop and surface rain water from the surrounding 3 buildings into the maidan; and possible backflow during high rainfall events, from the SWD network. Mosquito breeding due to waterlogging in the available common open spaces has also led to vector-borne diseases (YUVA 2019). The Lal maidan project is a potential site for increasing multi-use open spaces and prioritizing the creation of green areas.

Figure 3.9 Water logging in maidan during monsoon reducing usability of maidan and causing health issues due to contamination of water and spread of water borne diseases.

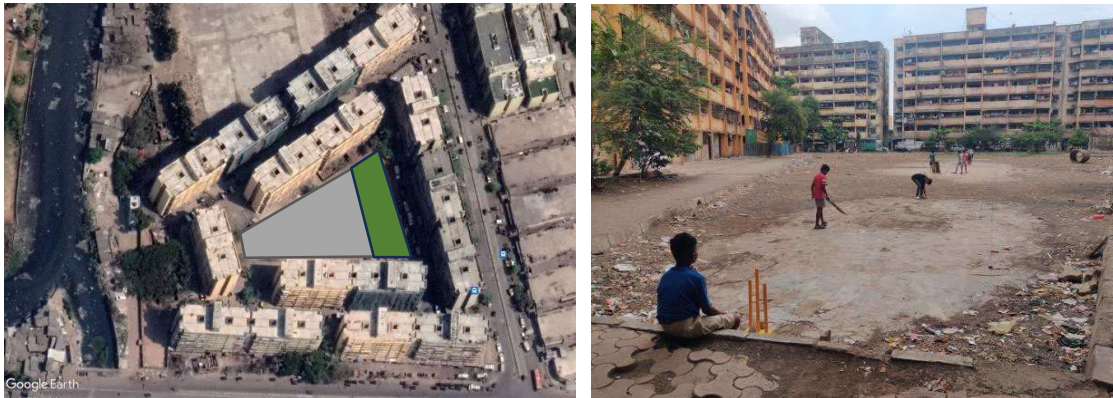
Figure 3.10 Concretization of the maidan. Grey colour indicated zone in above image shows the concretised portion of maidan. Image highlighting the concretised areas of maidan. This is a 6" slab of previously existing structure which is kept as it is and not demolished, leading to a lack of water absorptive surface area in this part.

- Due to the concretised base of maidan absorption of water in the ground is almost nil. Hence there is need of de-concretizing the base for rain water infiltration in the ground.
- As shown in Figure 3.11 the drain channels on 3 sides of maidan are blocked, hence do not drain the water away from the site. Also as shown in Figure 3.12 drain pipes under the pathways are blocked, hence there is need of new channels to infiltrate and drain the access water away from site to prevent water logging.
- Here, systems like the bioswale can be proposed to allow infiltration and to carry away excess water from the ground.

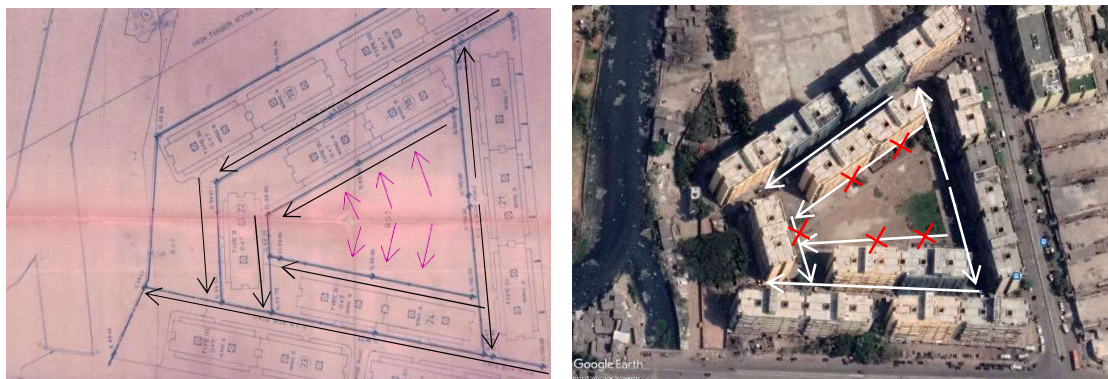
Figure 3.11 Image highlighting the currents status of SWD channels. Where cross marked drain channels along the edges of maidan has been completely closed by locals.

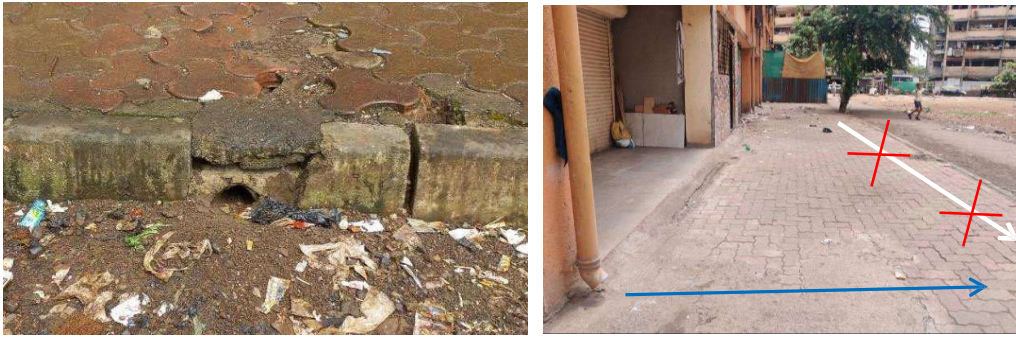
Figure 3.12 Block drain pipes under pathways around the maidan. (Right) Crossed lines indicate previously functional drainagae lines closed by residents. Blue is the flow of rooftop rainwater
